Utilization of on-line corrosion monitoring in the flue gas cleaning system

Published in:
Proceedings of NACE Corrosion 2015

Amager unit 1 is a 350 MW_{th} multifuel suspension-fired plant commissioned in 2009 which fires biomass. Increasing corrosion problems in the flue gas cleaning system have been observed since 2011 in both the gas-gas preheater and the booster fan and booster fan duct. A root cause analysis concluded that corrosion occurs due to corrosion products/deposit formed during operation; however it was unclear whether the majority of corrosion occurred during operation or downtime. In both cases the chlorine content in the flue gas results in the presence of chlorine species such as HCl, KCl or chlorine containing corrosion products. Without knowing when corrosion occurs, it is difficult to take reasonable measures to reduce corrosion. In order to gain an improved understanding of the corrosion problem, an on-line corrosion measurement system was established before the booster fan. The corrosion rates measured with respect to time were correlated to plant data such as load, temperature, gas composition, water content as well as change in the fuel used. From these r

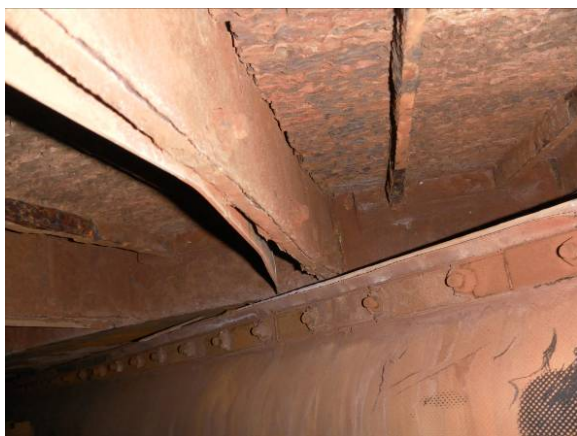
Increasing corrosion problems in the flue gas cleaning system (FGCS) had been observed since 2011 in the GAFO, where A242 steel corroded by 2 mm in 2 years. The AISI 316 bolts holding the sealing strips suffered from stress corrosion cracking leading to detachment of the UNS N10276 (Hastelloy C-276³) radial sealing strips.⁹ It was clear that the extensive corrosion was localized to the lower part of the GAFO –predominantly in the inner part and at the periphery. Investigations of the corrosion product showed a layered oxide where the highest chlorine concentration was detected close to the metal surface. Therefore the presence of chlorine had not given the optimal conditions for formation of a protective layer. Corrosion products removed from the lower part of the GAFO were mostly iron oxide (goethite). However at the inner surface attached to the metal, chlorine was present and akaganeite was detected. Close to the flue gas-oxide interface, more sulfur rich products were found together with iron, i.e. iron sulfate. Fine particles of potassium chloride were also observed. Varying degrees of corrosion were observed where the area closest to the rotor and at the periphery were the worst (Figure 2a). With the temperature of the GAFO rotor changing from 51°C to 85°C, some corrosion would be expected. However in some areas where the flue gas was warmer (approx 285°C in normal operation), corrosion was also observed (Figure 2b).

a) Outlet to GAFO close to axel

Figure 2: Different types of corrosion observed in GAFO

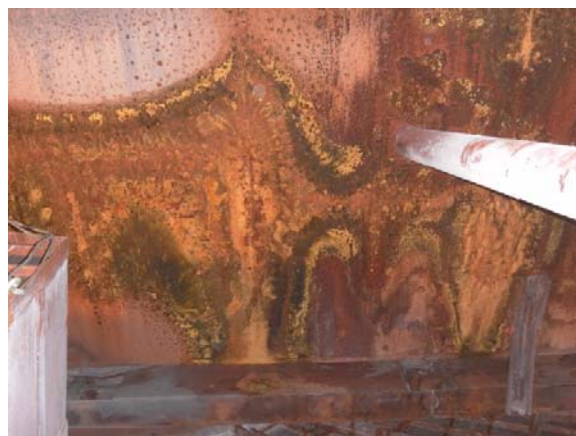
b) Above the GAFO on inlet side

Limited downtime corrosion has been measured compared to corrosion at start-up of operation. However during this measurement period, the corrosion picture in Figure 2b has not been observed. Thus the conditions to give this appearance have not occurred. Askey et al¹³ reports that the corrosion rate of iron in HCl gas atmospheres doubled from 25°C to 45°C. Thus the temperature profile during the shutdown process is important. Corrosion monitoring of a small coal fired plant (with UK coal) showed that high corrosion rates occurred 7-15 days after shutdown¹⁹ which indicates that the length of stop is also relevant.

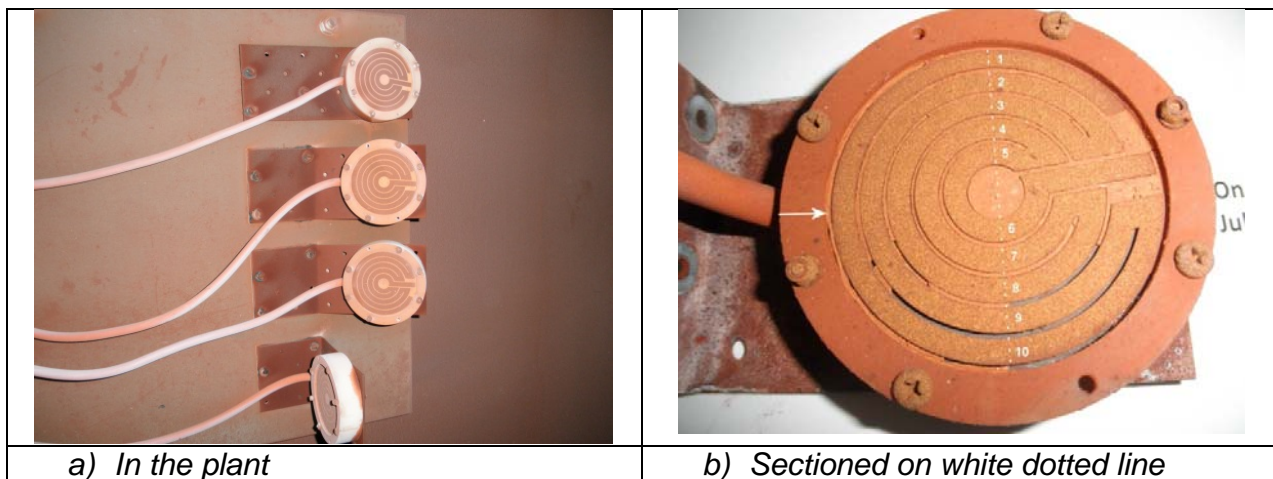
Figure 3: Photographs of ER sensor.

Four corrosion sensors were installed as shown in Figure 3. Sensors were fabricated in mild steel with different thickness (3 at 500 μm and 1 at 1000 μm as the rate of corrosion was not known) and at different angles to the flue gas flow (30°, 90° and parallel to the duct wall) in the location shown in Figure 1. Angled probes were chosen to try to measure the erosion contribution experienced by the booster blades which are positioned in the middle of the duct.

The sensors were installed during the summer overhaul 2013 and data has been collected for 11 months. The sensor location from the top is P1, P2, P4 and P3. It was clear that there are more deposit/corrosion products on the sensor angled perpendicular to the flue gas. The 500 μm sensors were removed in July 2014 and subjected to destructive analysis to verify the reliability of the measurements. They were cross-sectioned (Figure 3b) and measured to compare the thickness measurements with the ER measurements.

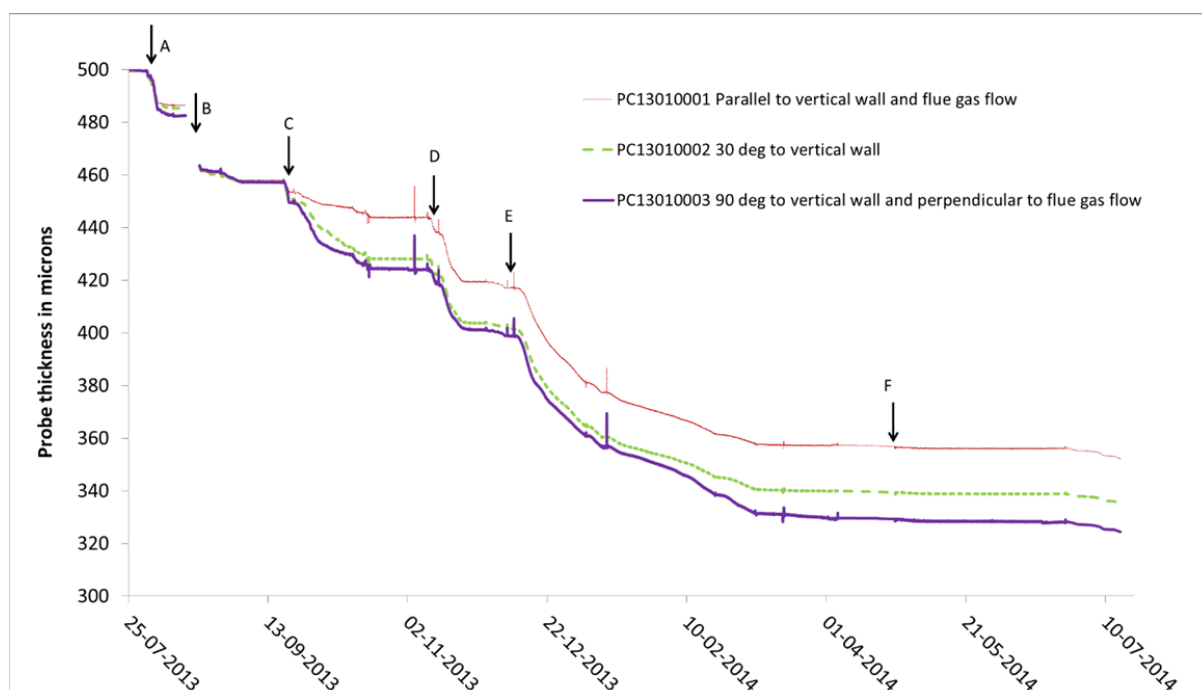
Figure 4: Comparison of 500 μm sensors from July 2013-July 2014.

The 1000 μm sensor showed similar trends to the 500 μm , so in this paper, the information from the 500 μm sensor will be used. Since similar trends were observed, the 500 μm sensors were replaced with 1000 μm sensors to give a longer lifetime. Figure 4 compares the data for the 500 μm sensors and it can clearly be observed that the sensors which are not parallel to the duct wall have a tendency to a higher corrosion rate even at the beginning of the exposures in August 2013, where the 90° angled sensor had the higher thickness loss. Visual observation showed there is more deposit/corrosion product on the sensors not parallel to the wall such that deposit amount decreases as follows $90^\circ > 30^\circ > 0^\circ$. Different plant data was correlated to the sensor data. The main parameters are temperature and water content in the flue gas, however other characteristics such as plant load, flue gas flow, SO_2 , NO_x , O_2 , soot blowers, etc. were correlated. The water content measurement was not close to the sensor but from the stack, so although it is a useable measurement when the plant is in operation, this is not the case during shutdown or bypass operation. There is not a gradual metal loss but there are events which precipitate thickness reduction, and these are indicated on Figure 4.

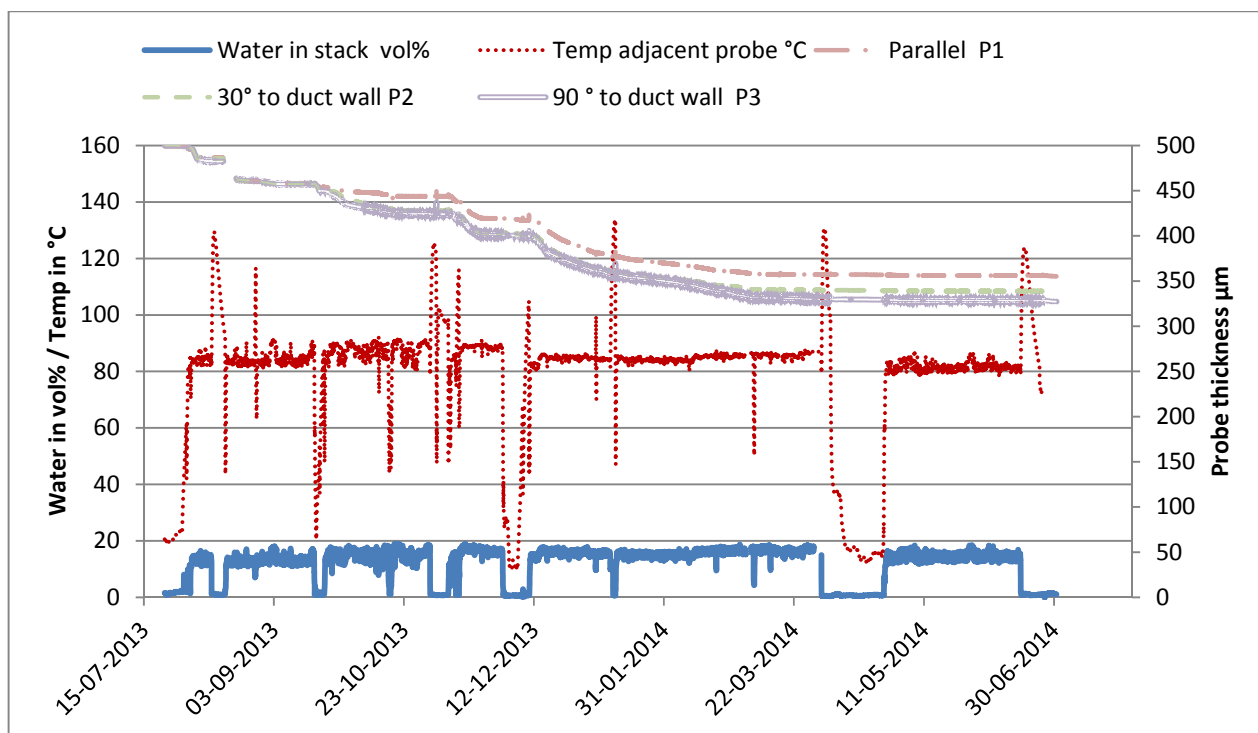
Figure 5: Corrosion profile correlated to temperature and water/oxygen content in the stack.

It was clear that in 2013, these events coincided with shutdown/start-up episodes as shown in Figure 5. When water content in the flue gas drops, this indicates that the plant has been shut down. In some cases the temperature in the FGCS is kept warm, however if access to the FGCS is required, this part of the plant is cooled rapidly. The start-up of the plant is marked with arrows A, B, C, D, E and F on Figure 4. The arrow F, also corresponds to a startup, however there is no increased corrosion.

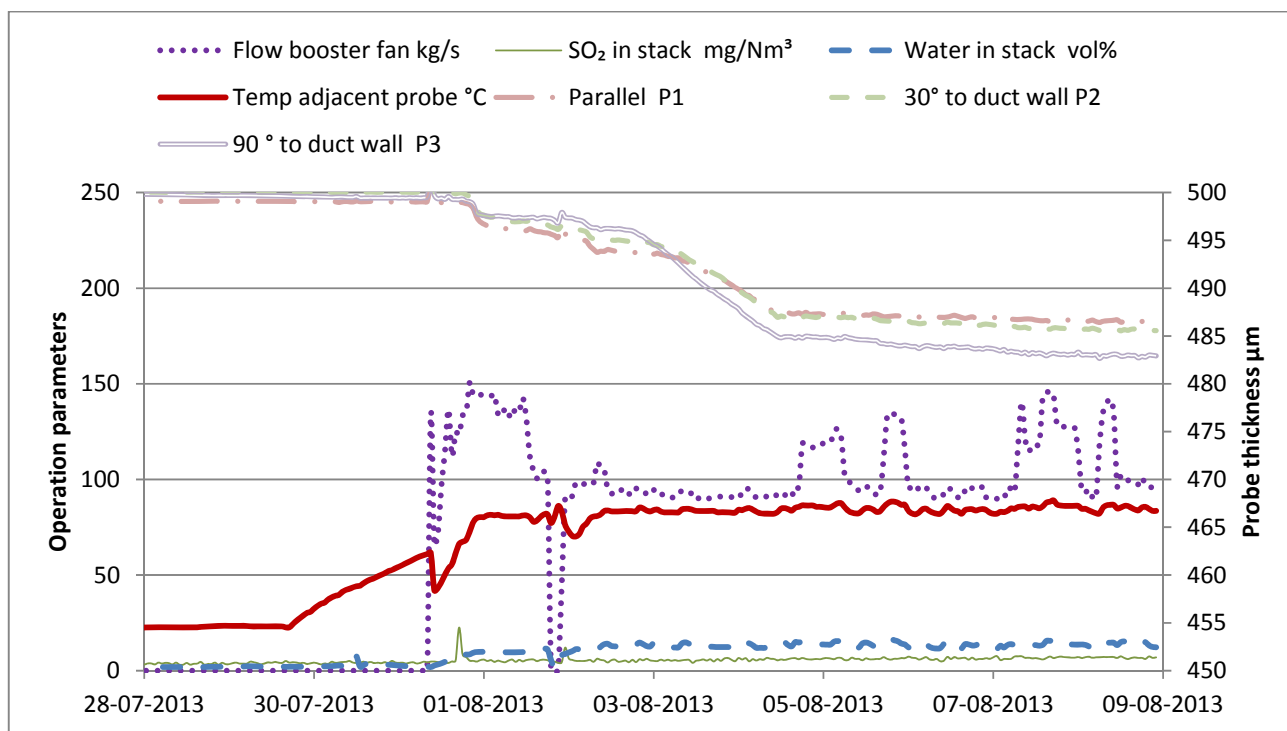
Figure 6: Event A – Corrosion profile correlated to start-up conditions

Event A was when the plant was started up on 31st July 2013 after the corrosion sensors were installed. The corrosion sensors were newly prepared and without visible deposit. Figure 6 illustrates how corrosion began during start-up where the flue gas flow started, and the corrosion increased first during start up, probably to form the initial oxide layer (3-4 μm), but then continued for a short time after start-up. The flow varied during start-up, but apart from the initial start-up, this cannot be linked with the thickness decrease in the sensors. There were also spikes from SO_2 and NO/NO_x during start-up.

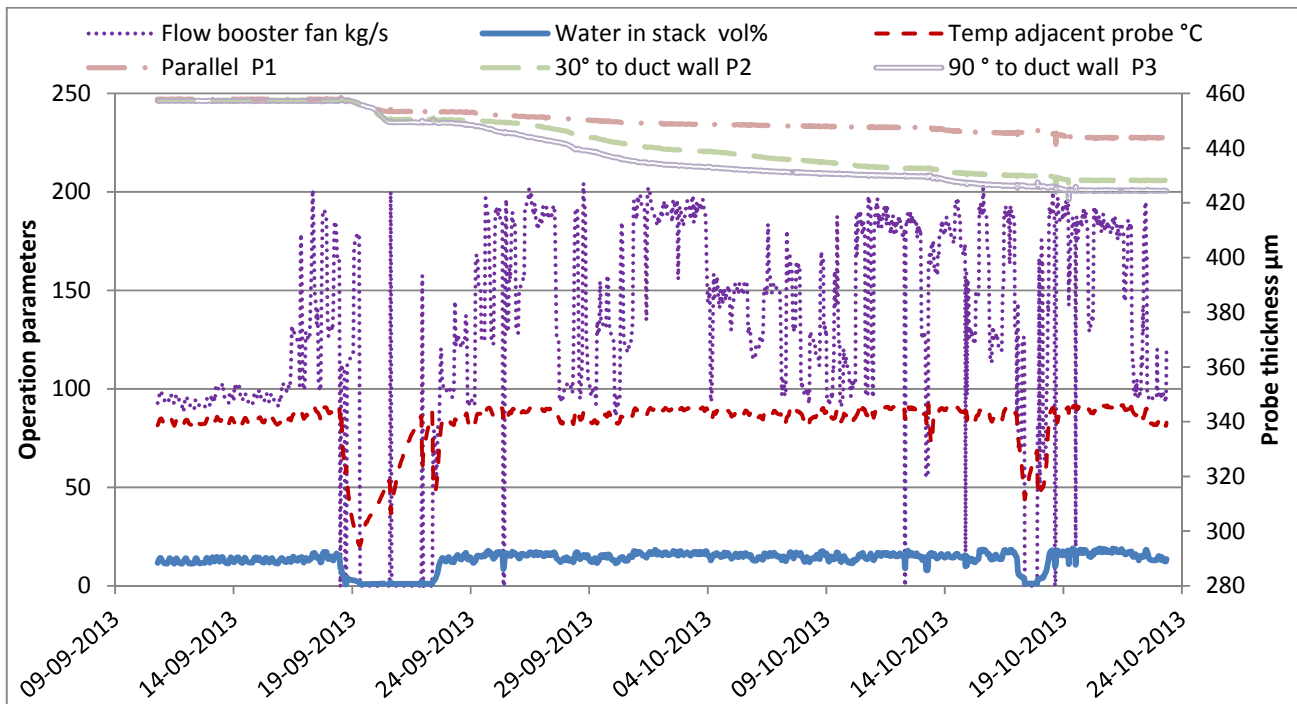
Figure 7: Event C - Short shutdown where GAFO temperature is decreased.

For Event C, an increase in corrosion as the plant is shut down was observed followed by a gradual corrosion rate on start-up which lasted almost a month.

Only Event C showed a marked difference with respect to angle of the sensor. The only factor that could be linked to this was the fluctuating load and therefore flow in the flue gas. Perhaps such an operation mode leads to more erosion due to water droplets or other particles; this needs to be further investigated when a similar corrosion profile is observed. It cannot be ruled out that the actual position of the individual sensors also has an influence as metal loss measurements across the 90° sensor revealed less corrosion on the upper part.

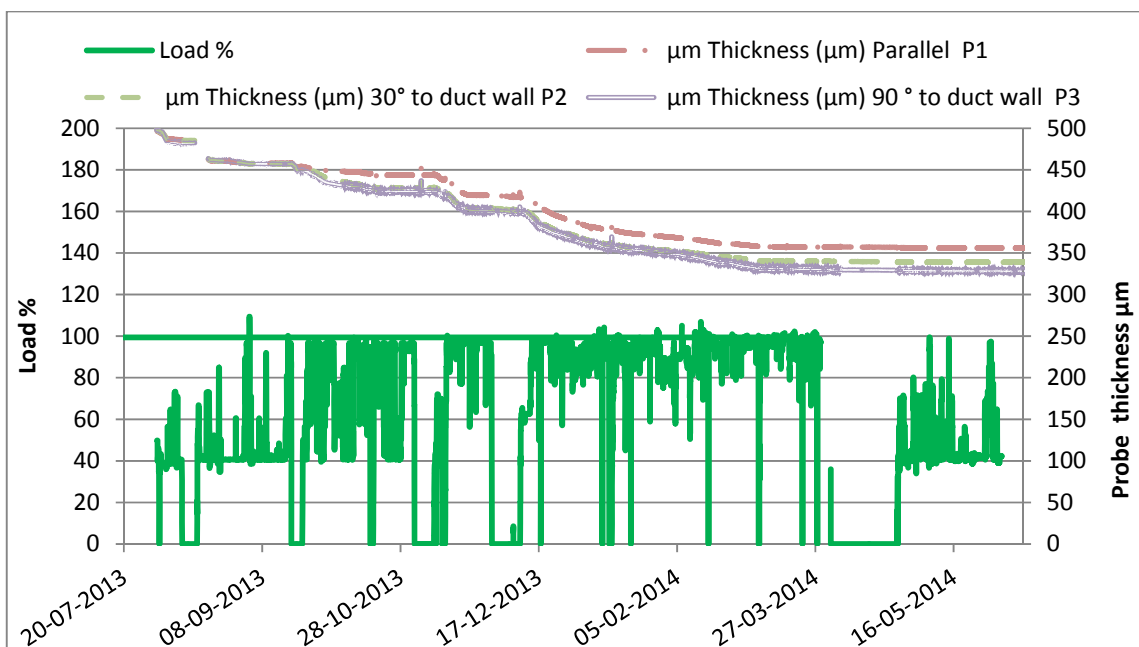
Figure 8: Corrosion profile with respect to load.

It is evident that the 90° sensor and 30° sensors incurred more corrosion compared to the sensor parallel the duct wall and that this corrosion or erosion occurred whilst the plant was in operation. The only operation condition which could correlate with this event was the variable flow caused by variable load (Figure 8). A higher load means that there is greater flow of flue gas, but also more movement of deposit/water droplets through the system. Reasons for higher corrosion or erosion due to changing load are difficult to explain.

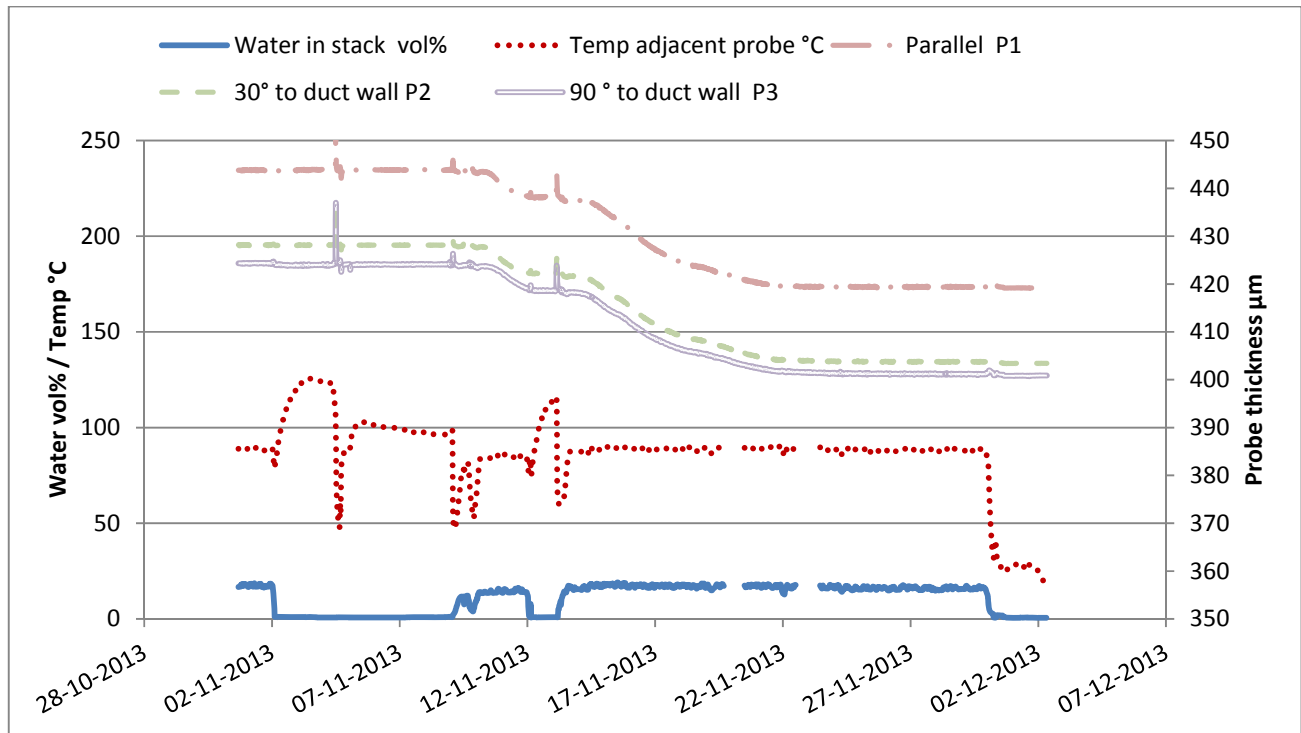
Figure 9: Event D - Corrosion profile with respect to temperature and water content.

Event D consists of two sub events (D1 and D2) which closely follow one another (Figure 9). The plant was shut down around the 2nd November 2013, and the GAFO was kept warm. Only marginal corrosion was observed during shutdown although there was a short temperature spike in the GAFO (probably someone opened a manhole). When the plant came back into operation, the corrosion started.

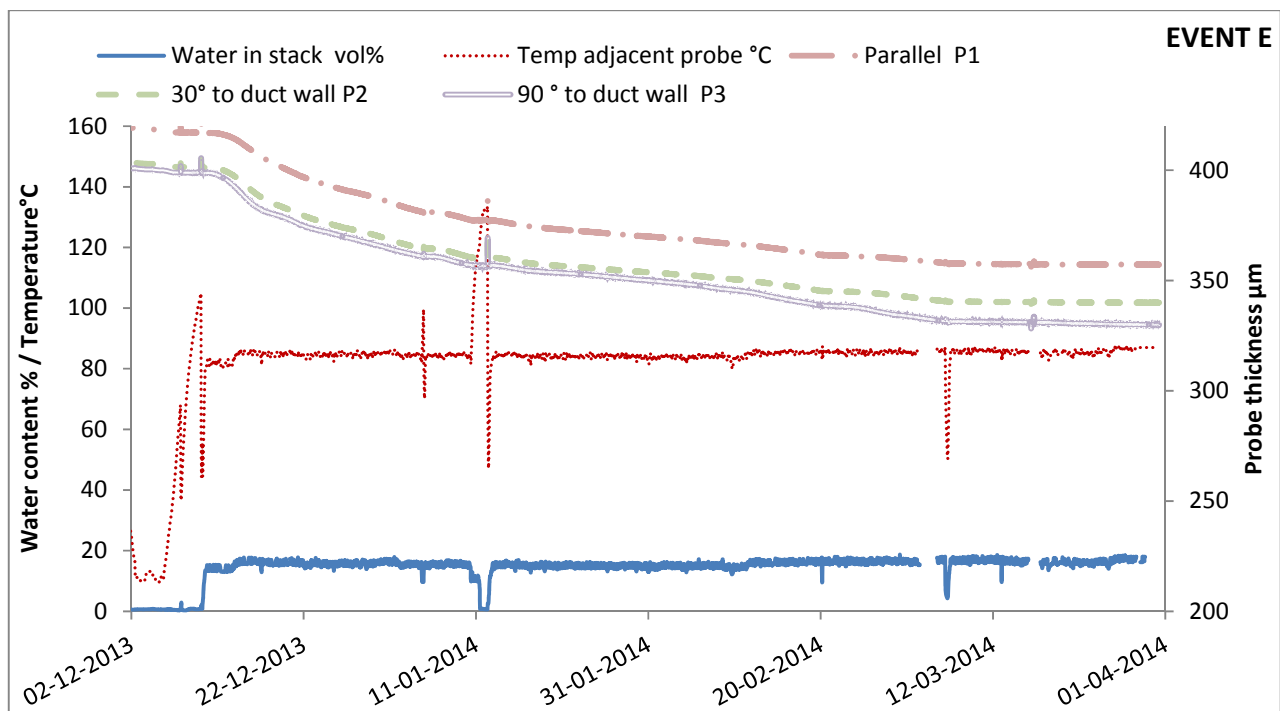
Figure 10: Event E - Corrosion profile with respect to temperature and water content.

Again there was a gradual corrosion rate and it had probably not yet reached its full extent before the next shutdown occurred a few days later. Start-up again precipitated corrosion and continued as a gradual corrosion rate over the next two weeks. There was no sharp increase in corrosion before the gradual corrosion as seen in Event A.

From December 2013, only wood pellets were fired. The corrosion profile of Event E showed a slightly higher corrosion rate after start-up which then continued with a slower corrosion rate for about two months. During February, the corrosion rate of the 90° sensor increased slightly more than the others, and slightly higher water content in the flue gas was measured. Event E had the largest metal loss although it was a period when only wood pellets were used.

When only wood pellets are used, then the HCl content would be much lower, thus the amount of HCl condensing on the corrosion product on component surfaces is much lower. However during Event E, there is already Cl species incorporated into the deposits as akaganeite or FeCl_2 from the earlier straw-pellet firing. As a result, these can form soluble salts and thus corrosion can continue until the available chlorine is reduced. In this case it takes over two months for the corrosion rate to be minimal, which could be termed a memory effect from the straw pellets.

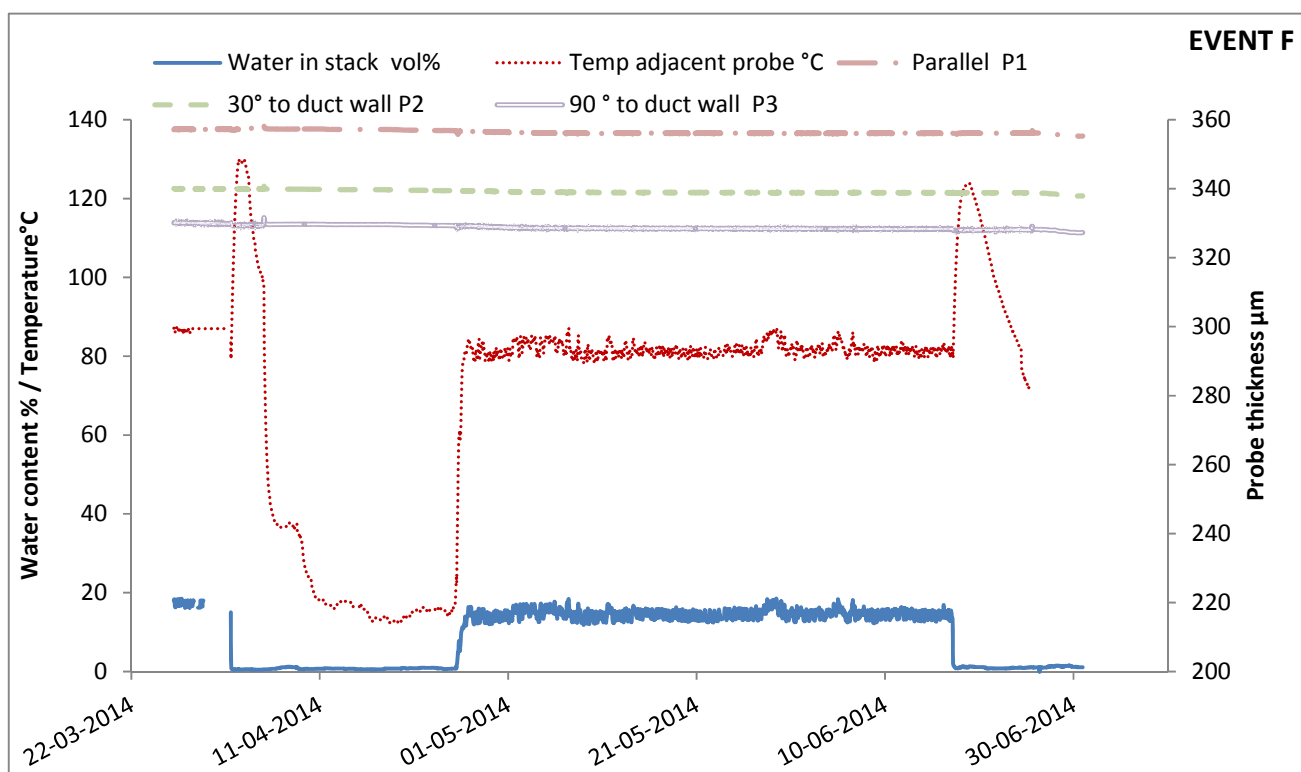
Figure 11: Event F - Corrosion profile with respect to temperature and water content.

The final event F is somewhat a non-event and therefore the most interesting (Figure 11). The plant was shut down and started up with negligible effect on corrosion.

Minimal corrosion occurred after Event F indicating that chlorine presence is too low in the flue gas to initiate corrosion. The load during this event was 40% (Figure 8), and with 100% load, a corrosion event is more likely to occur. However there was also partial load with wood+straw pellets in August, so an improvement is evident from removing straw pellets as a fuel. More data on subsequent events is required to confirm this trend. From experiences in Sweden, corrosion is observed with woodchips but then the water content would be closer to 20 vol. %⁴, or other salts could be present such as CaCl_2 .

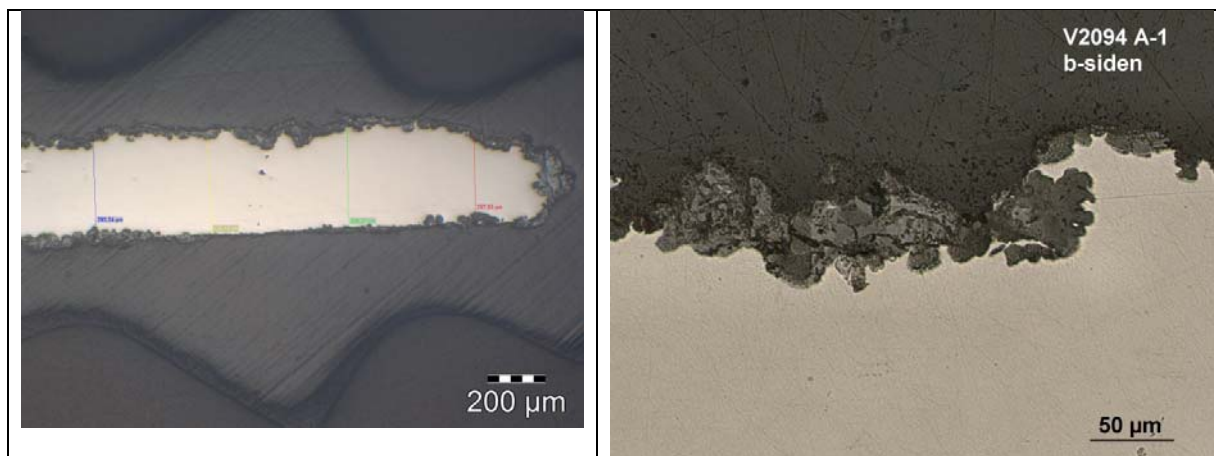
The exposed corroded element of the sensors was cross-sectioned as shown in Figure 3b. The reference element behind the exposed element of the sensor was measured to 481 μm (± 2 μm). For the on-line measurements, the reference thickness was set to either 500 μm or 1000 μm and the corrosion was monitored relative to this set reference. The actual thickness reduction has not changed, however for comparison with optical microscopy and on-line measurements; the actual thickness of the reference electrode (481 μm) was used. As can be seen in Figure 12, the corrosion was not general corrosion but pitting corrosion. The measurements shown in Figure 13 were measurements taken on cross-sections from positions 1-10 on Figure 3.

Figure 12: Light optical micrographs of cross-section of the corroded element P3 (90°).

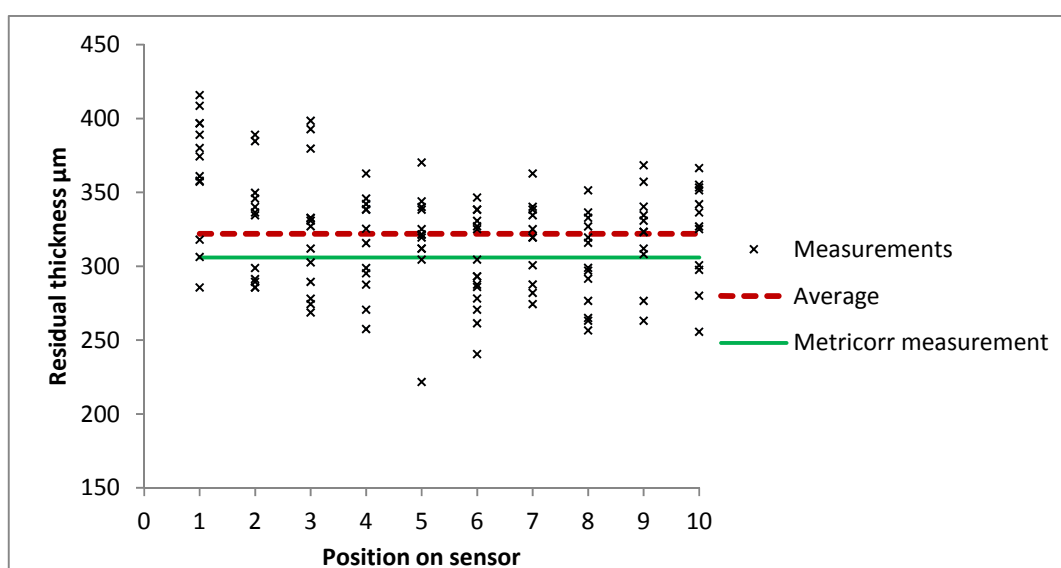
Figure 13: Measurements of sensor element 3 (90 angled) compared to ER measurement.

The average residual thickness for sensor 3 was 321 µm (± 30 µm). There was a great amount of scatter in the residual thickness which was probably due to the corrosion being pitting corrosion rather than general corrosion. The corrosion measured by the on-line sensor was 305 µm. Therefore the on-line measurements were a good assessment of corrosion. Interestingly, the corrosion rates measured at position 1 (and perhaps 2 and 3) were slightly higher. This could be related to a varying gas composition through the cross-section of the duct, or perhaps a shielding effect at the top of the sensor.

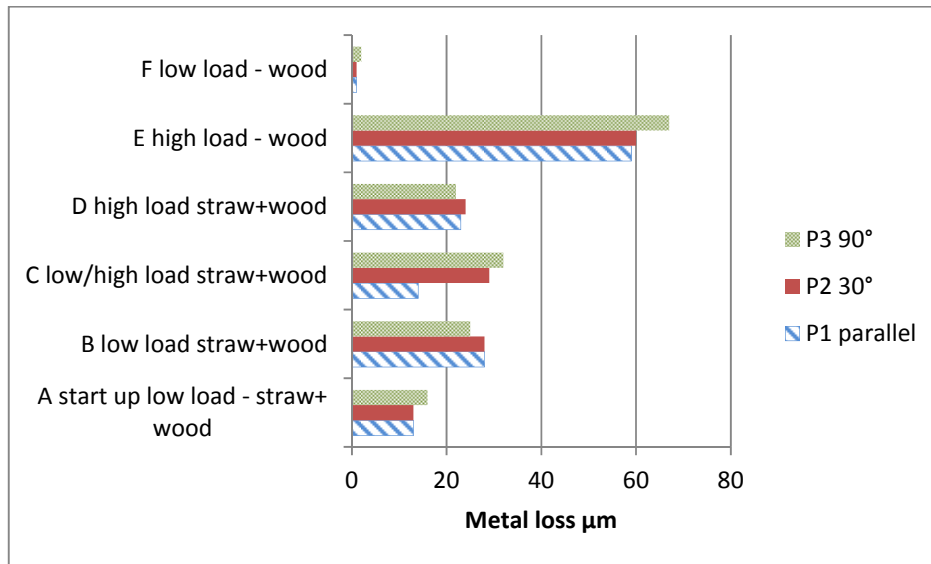
Figure 14: Comparison of start-up events.

An overview of the various events is given in Figure 14 with the metal loss measured with the ER sensors regardless of event duration. The duration of these events increases, until there is negligible corrosion during the last start-up. When the plant start-up is from room temperature, then there is an initial period of high corrosion rates, as the component is subjected to flue gas and is passing both the H₂O and HCl dewpoint. This will result in the formation of oxides and chlorides according to some of the reactions below. HCl can also be released again to react with oxides or iron at the corrosion front but it can also be lost to the flue gas.
